Chestnut & Elm Street Redevelopment Area Request for Proposals from Interested Developers Bristol Borough, PA

ADDENDUM #3

Re: Chestnut & Elm Street Redevelopment Area – Request for Proposals
Addendum #3

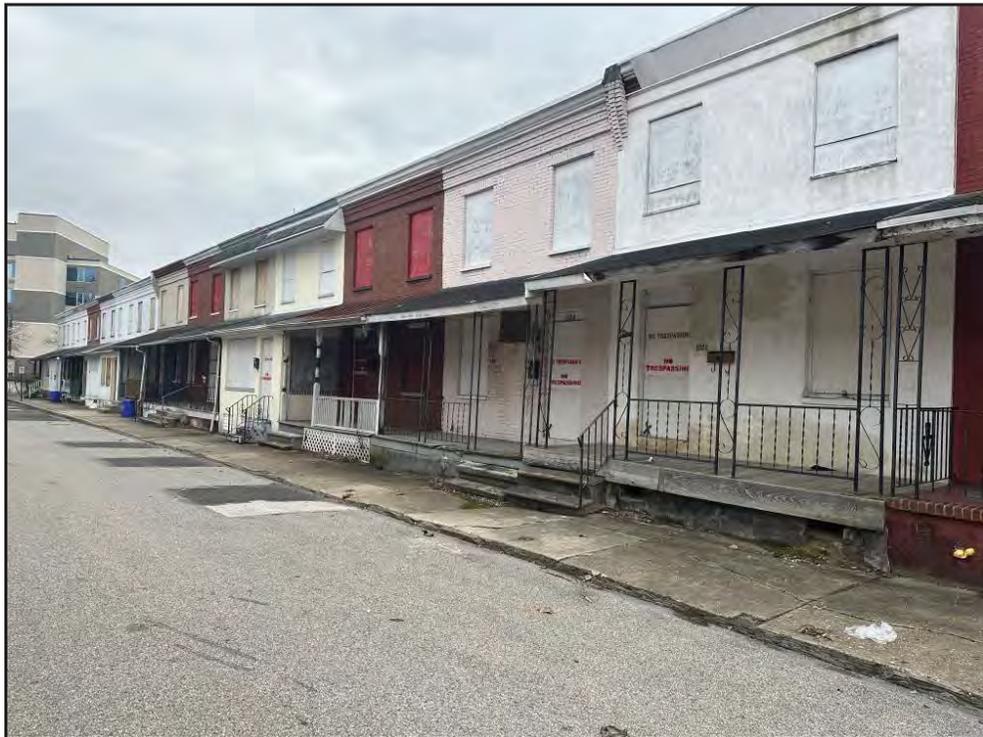
Residential properties on the south side of Chestnut Street.

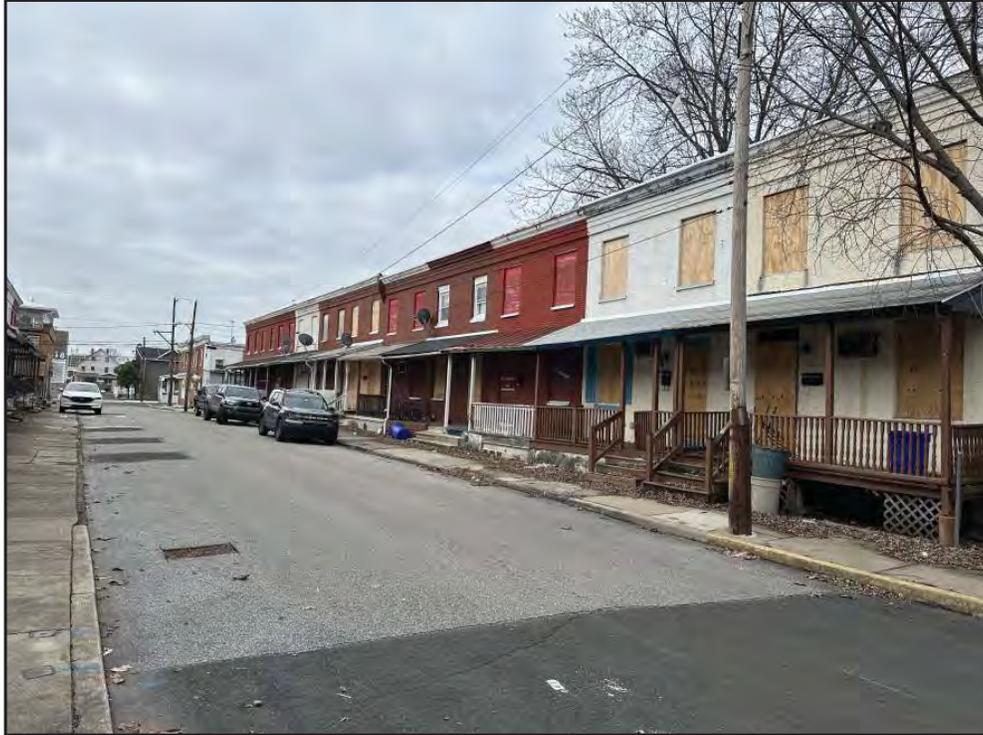
At the time of site reconnaissance, the residential structures (row homes) on Chestnut Street were observed to be abandoned with the exception of house number 1042. The row homes on Elm Street had reportedly been demolished several years prior.

Residential units on the north side of Chestnut Street.

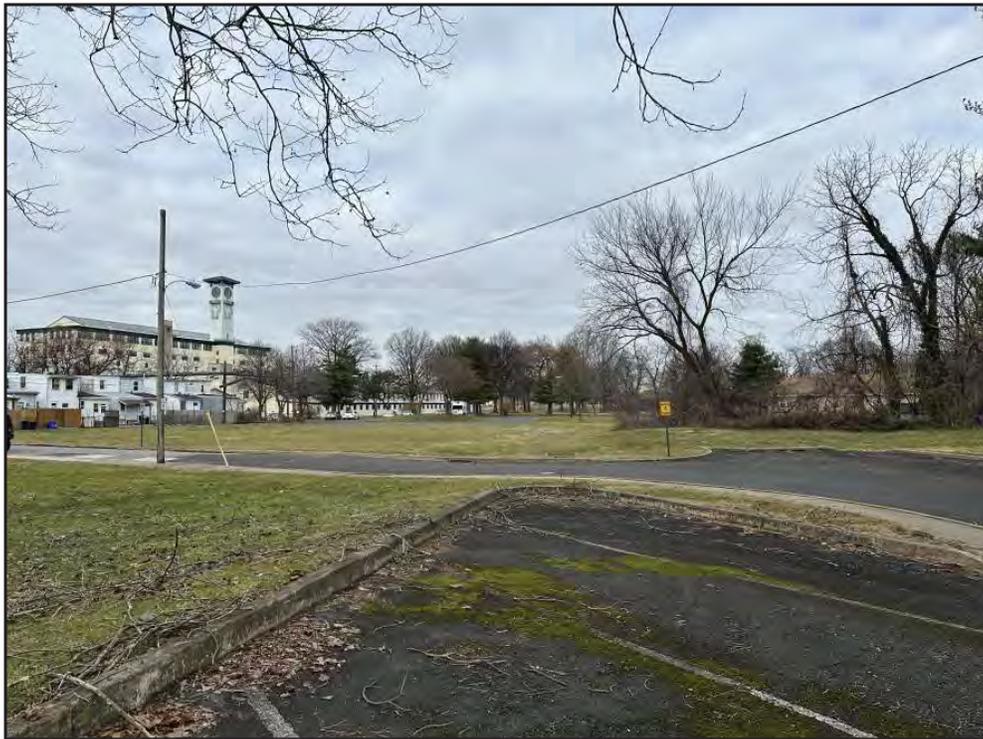
Location of the historic residential units on Elm Street.

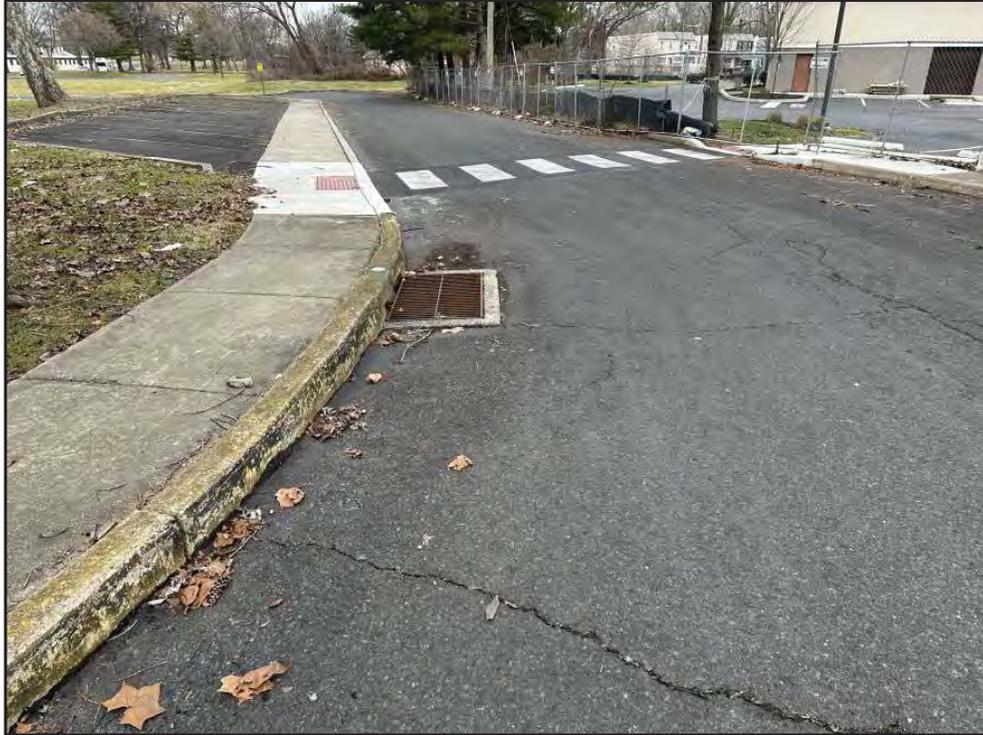
Stormwater inlet on the subject property.

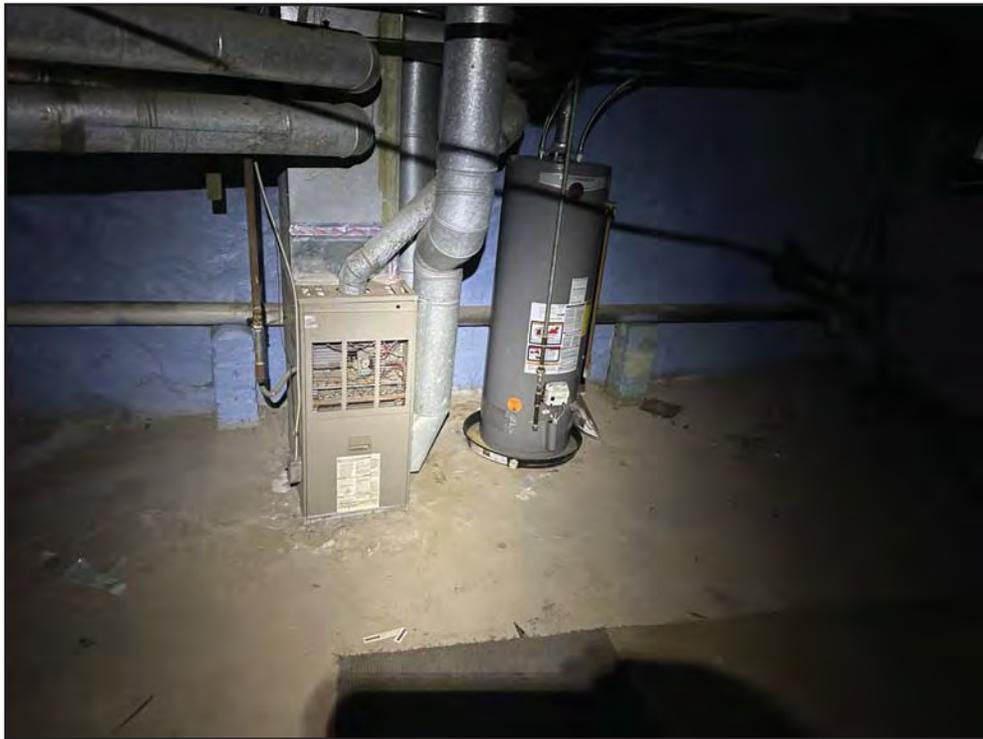
Heating / Cooling System	At the time of site reconnaissance, G&A observed that the subject property utilizes natural gas for heating and electric for cooling with the exception of 1015 Chestnut Street.
Fill Material	None found at the time of site reconnaissance.
Rail Roads	None found at the time of site reconnaissance.
Other Concerns	None found at the time of site reconnaissance.

Representative picture of the natural gas furnaces.
