Chestnut & Elm Street Redevelopment Area Request for Proposals from Interested Developers Bristol Borough, PA

ADDENDUM #3

Re: Chestnut & Elm Street Redevelopment Area – Request for Proposals
Addendum #3

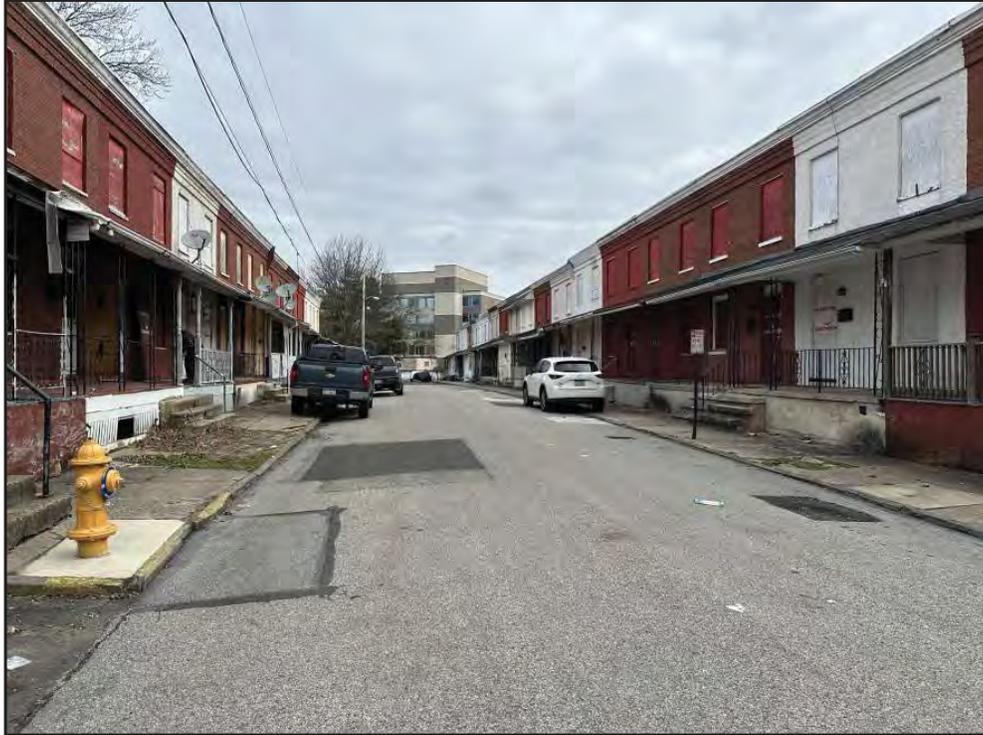
The subject property.

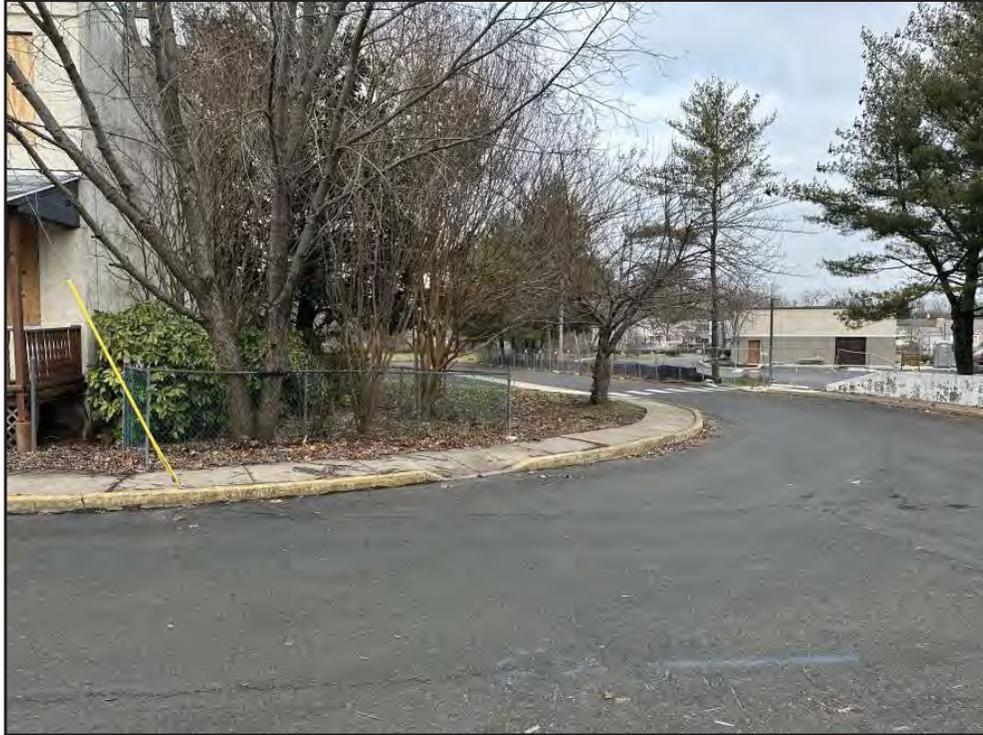
East side of the subject property.

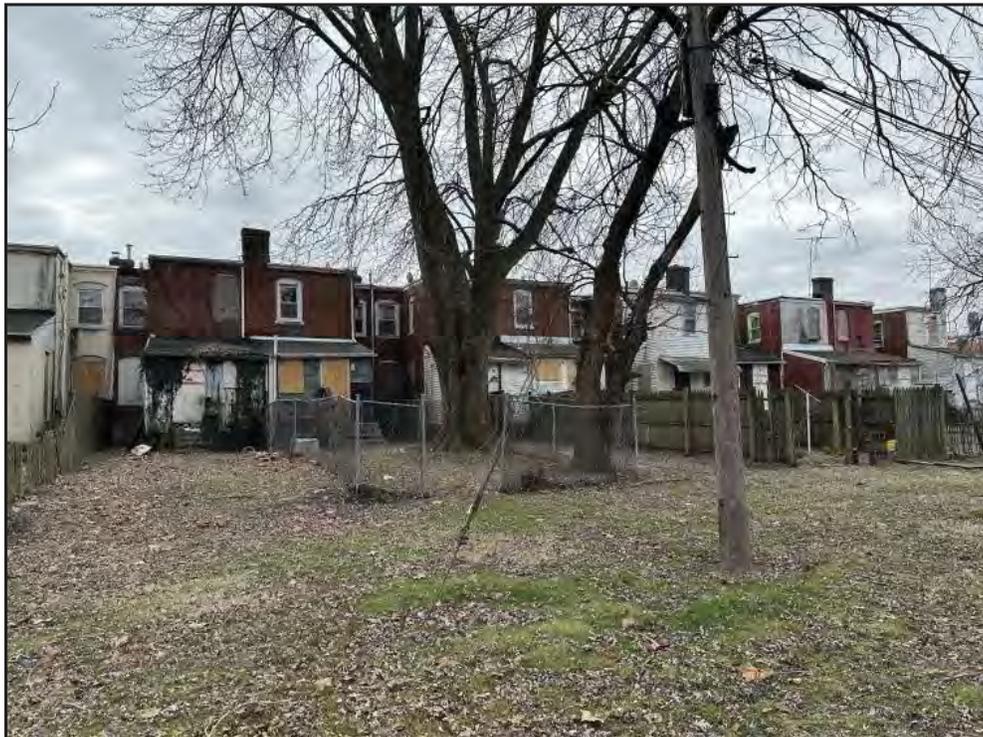
Rear of units on the north side of Chestnut Street.

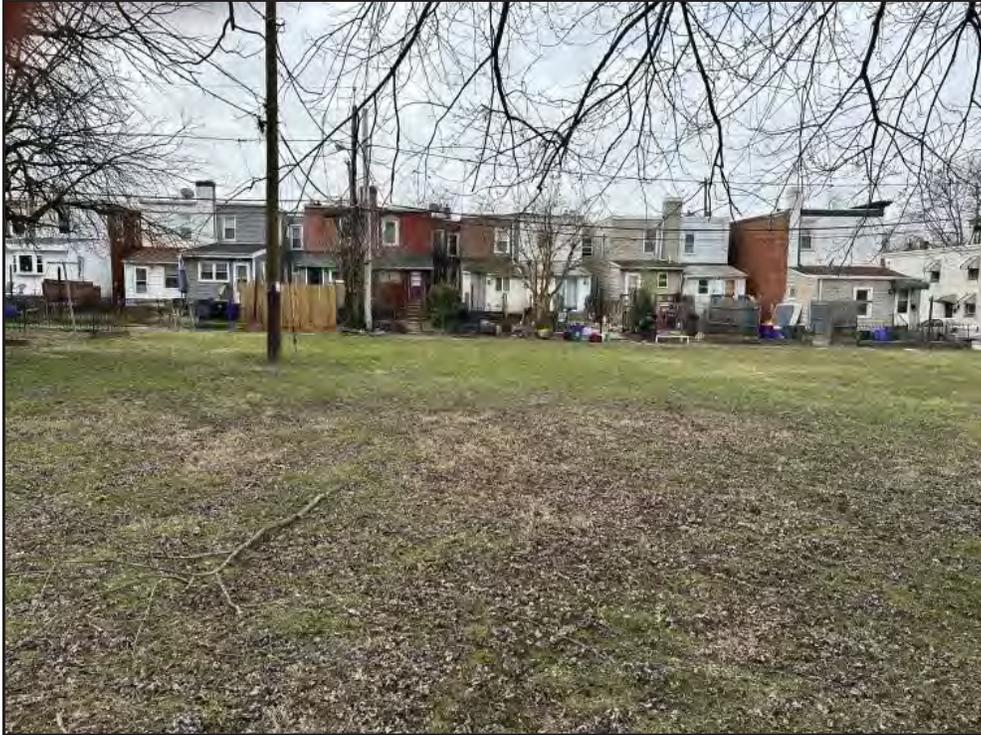
Adjacent properties to the west.

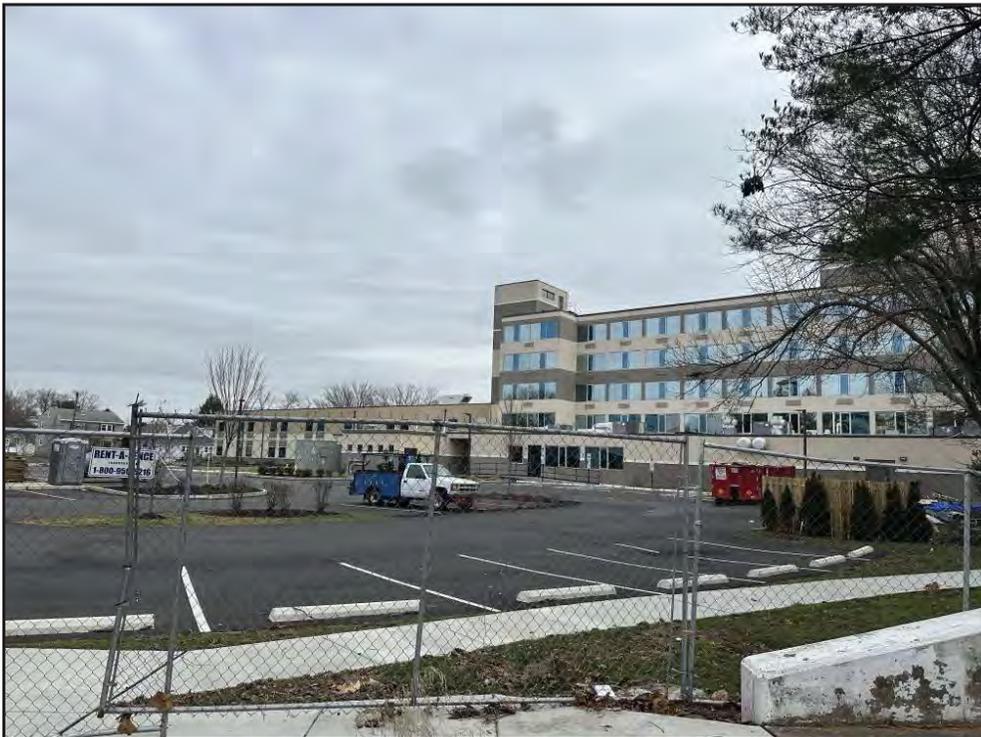
Adjacent property to the east.

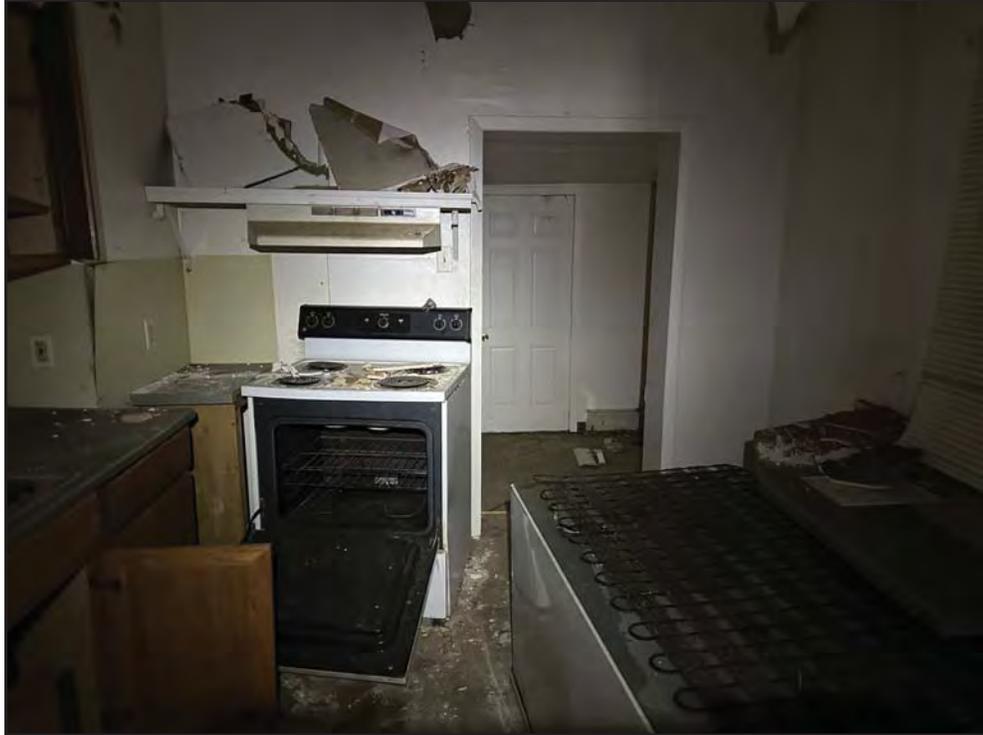
Representative picture of the kitchen.

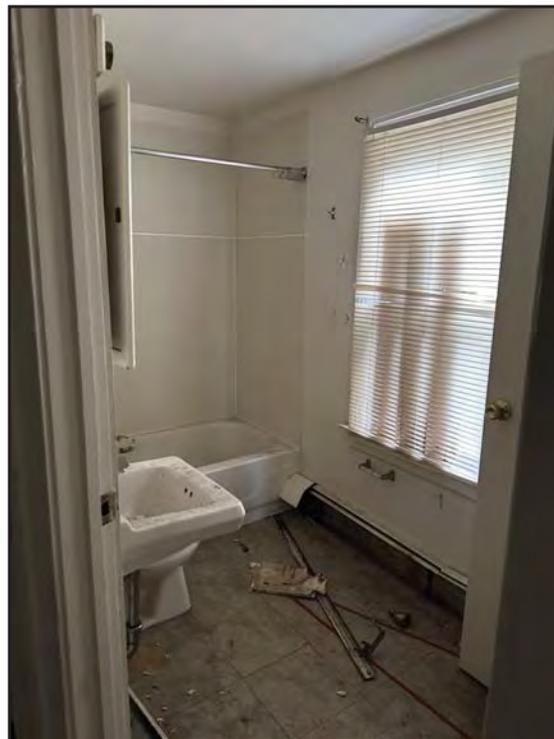
Upstairs bathroom.

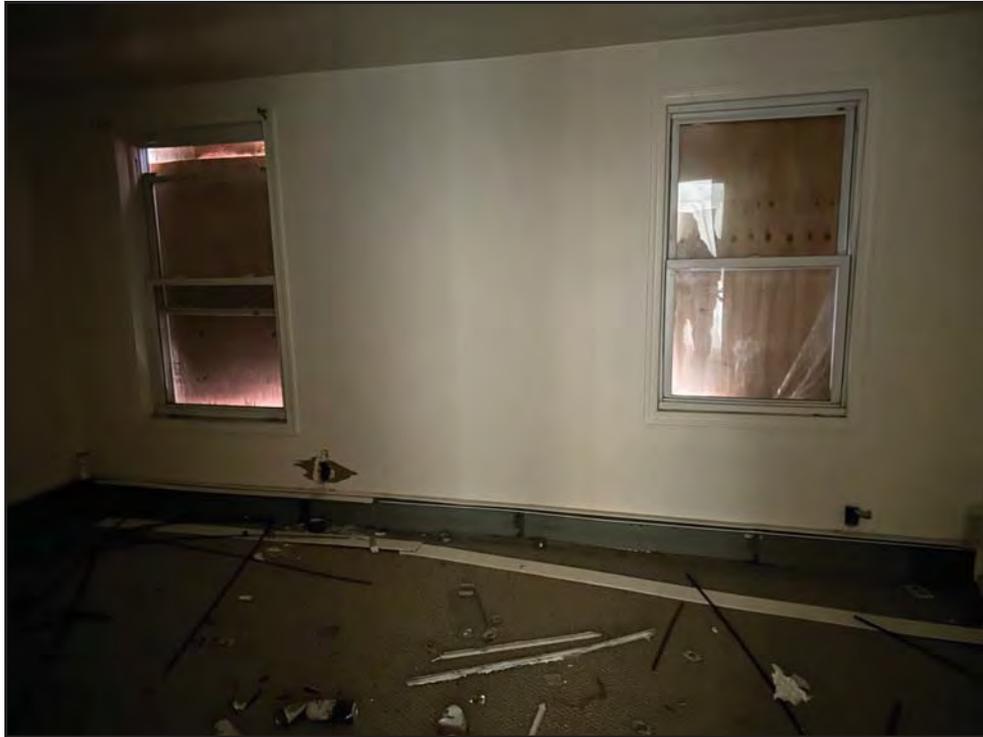
Upstairs bedroom.

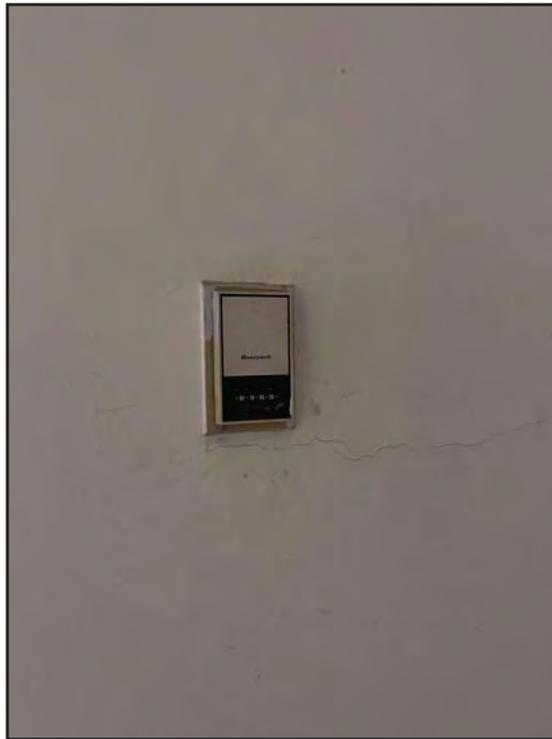
A Universal Waste assessment was also conducted to evaluate the presence of PCBs, mercury, freon, and other hazardous materials. Wastes observed in the residential structures included fluorescent light bulbs, light ballasts, thermostats, and an AST which contain mercury, PCBs, and hydrocarbons.

Mercury thermostat.

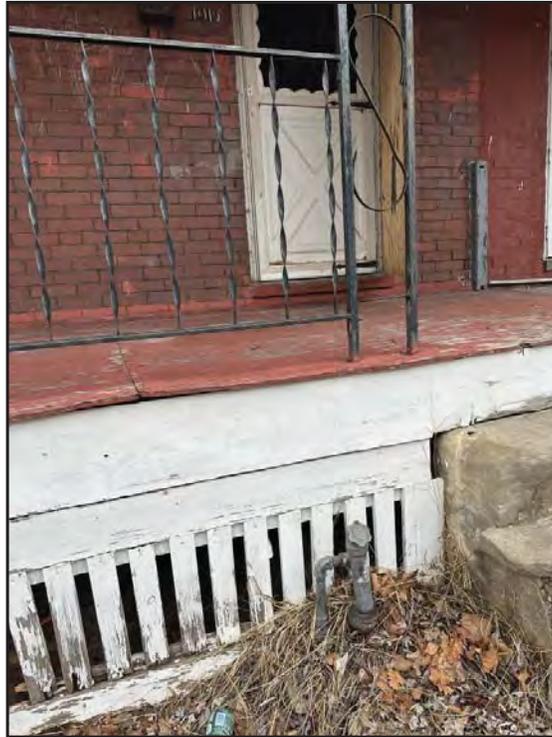
Heating / Cooling System	At the time of site reconnaissance, G&A observed that the subject property utilizes natural gas for heating and electric for cooling with the exception of 1015 Chestnut Street.
Fill Material	None found at the time of site reconnaissance.
Rail Roads	None found at the time of site reconnaissance.
Other Concerns	None found at the time of site reconnaissance.

Fill port and vent outside of 1015 Chestnut Street.
